**Pinner Wood School, Latimer Gardens,  
Pinner, Middlesex HA5 3RA**  
**Interim Interpretive Report on Subsidence Investigation**

On behalf of **People's Capital Project Team, Harrow Council**

Project Ref: 35665/3506 | Rev:4 | Date: July 2017

**Report Title:** Interim Interpretive Report on Subsidence Investigation

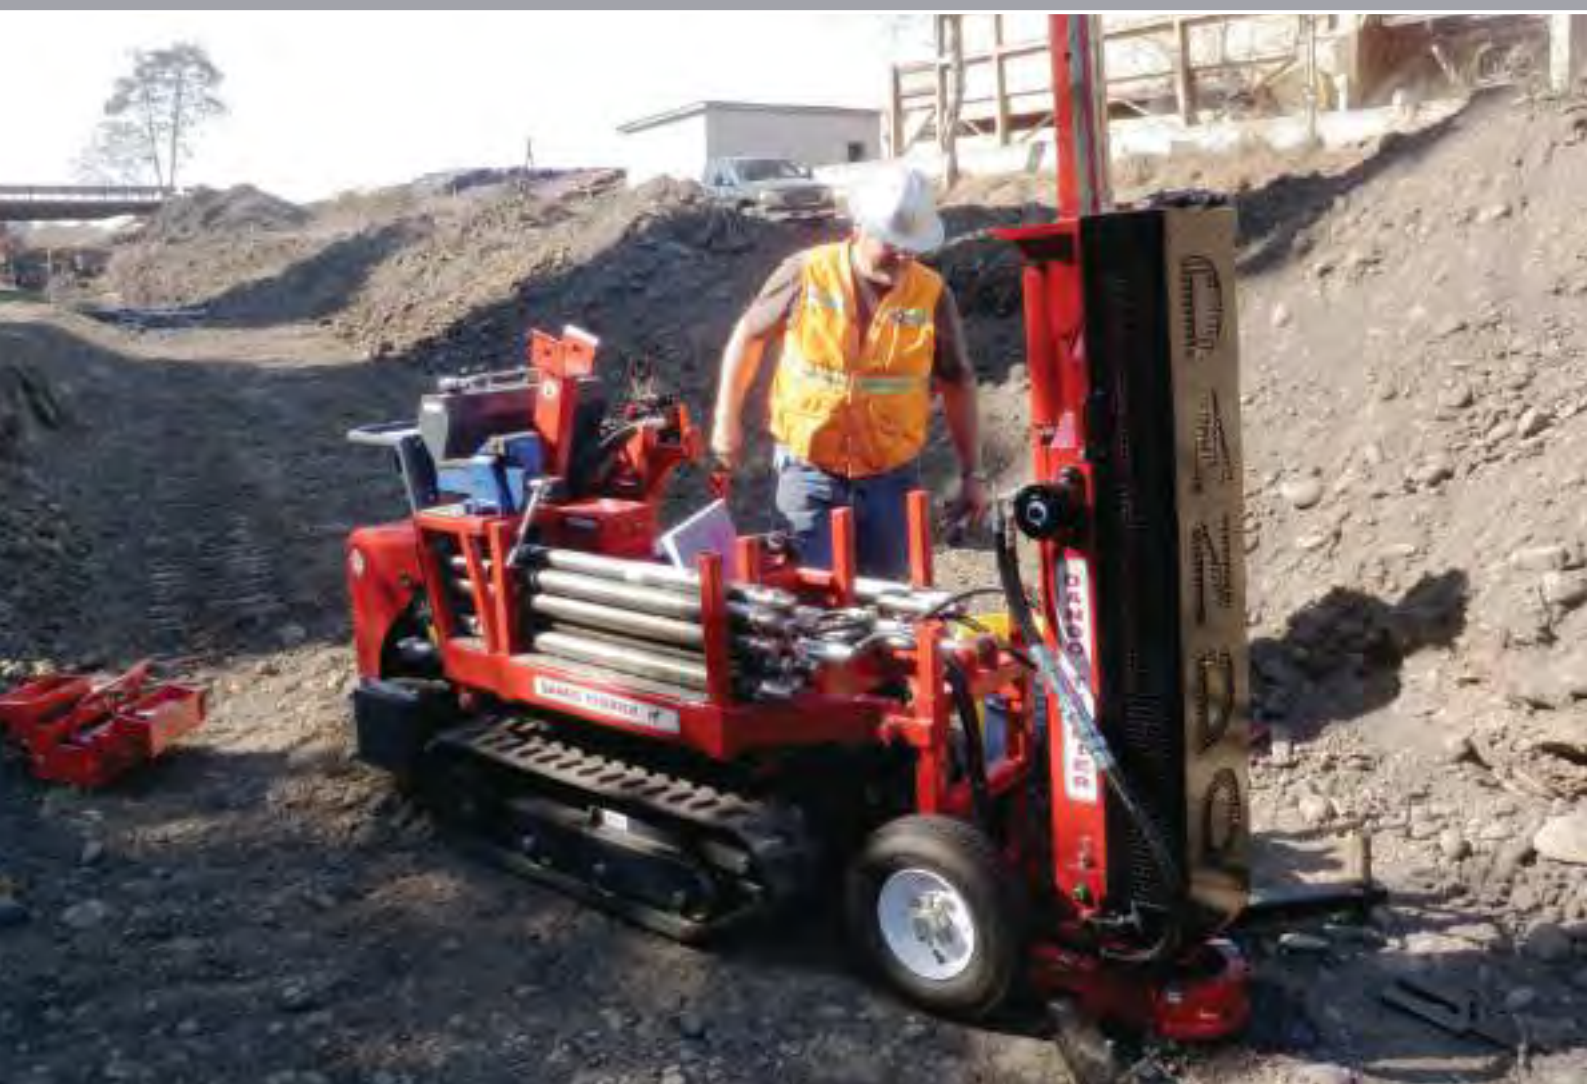
## Dando Terrier

The ultra-small, compact Dando Terrier rig has been designed specifically for sampling and testing for geotechnical and environmental analysis and is crawler mounted for easy site access in difficult conditions. Simple to operate and maintain, extremely reliable and competitively priced.

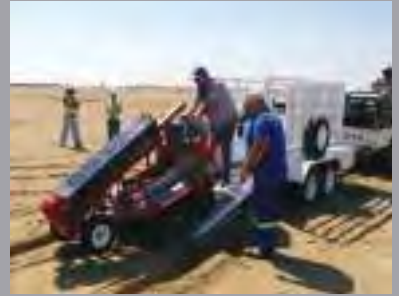
Compact manoeuvrable crawler-mounted design ideally suited for long wheel-base transit type vans for fast mobilisation to site and secure storage of all equipment.

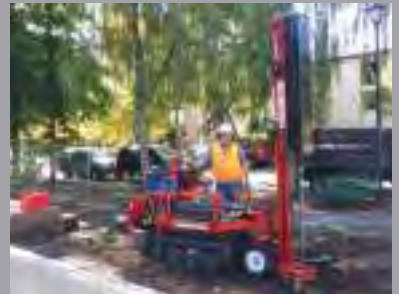
2-piece drop hammer for sampling and testing incorporated in mast assembly with hydraulic cylinder giving 7000 kgf pullback for recovery of casing and sampling tools. Mast assembly can be detached for remote operation in restricted access locations.

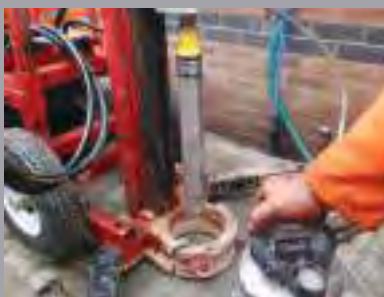
Concrete coring head- useful when concrete and tarmac overlies the area to be sampled.

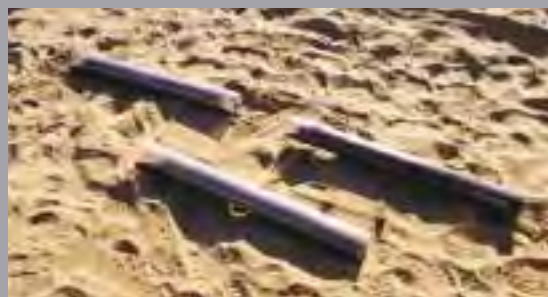
Range of windowless sample tubes with plastic liners ensuring high quality samples, good presentation and ease of handling and transportation.

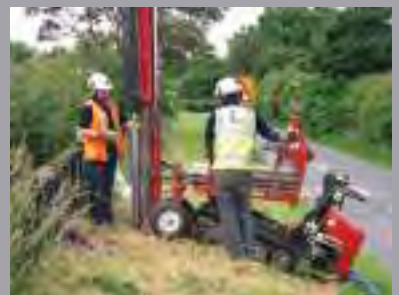
Hydraulic tilting undercarriage allows operation on inclined slopes up to 30 degrees from horizontal. Deck area with storage capacity for all required drilling tools.

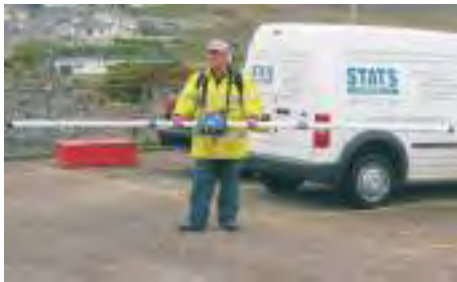
**C** An example of electromagnetic data showing various buried obstructions

In electromagnetic mapping, individual measurements are recorded across a site at a suitable density and plotted as a contoured map (**Figure 4B**). Measurements may also be recorded at different depths according to the orientation (either vertical or horizontal) of the transmitter and receiver coils.

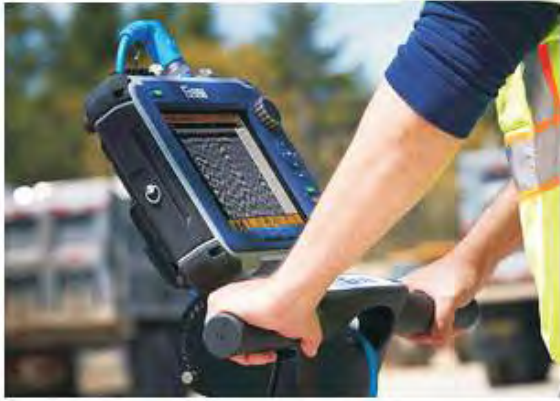
# GSSI SIR-4000 RADAR

***A portable, digital Subsurface Interface Radar System designed for a broad range of environmental, geotechnical, geological and engineering applications.***

The SIR® 4000 is GSSI's first high-performance GPR data acquisition system designed to operate with analog and digital antennas. This evolutionary step allows true versatility and flexibility by supporting a wide range of users, beginner to advanced, in numerous applications.

The SIR 4000 incorporates advanced display modes and filtering capabilities for 'in-the-field' processing and imaging. Fully integrated, the system provides a simple user interface, plug-and-play GPS integration, and WiFi enabled data transfer capabilities.

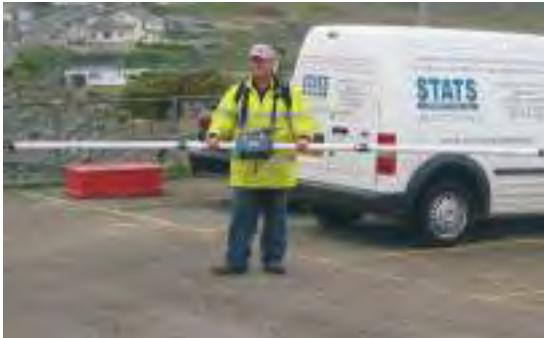
***A portable, lightweight, dual coil ground conductivity instrument designed for a broad range of environmental, geotechnical, geological and engineering applications.***

The Geonics EM31 maps geological variations, groundwater contaminants or any subsurface feature associated with changes in ground conductivity, using a patented electromagnetic inductive technique that allows measurement without electrodes or ground contact. With this inductive method, surveys can be carried out under most geologic conditions including those of high surface resistivity such as sand, gravel and asphalt.

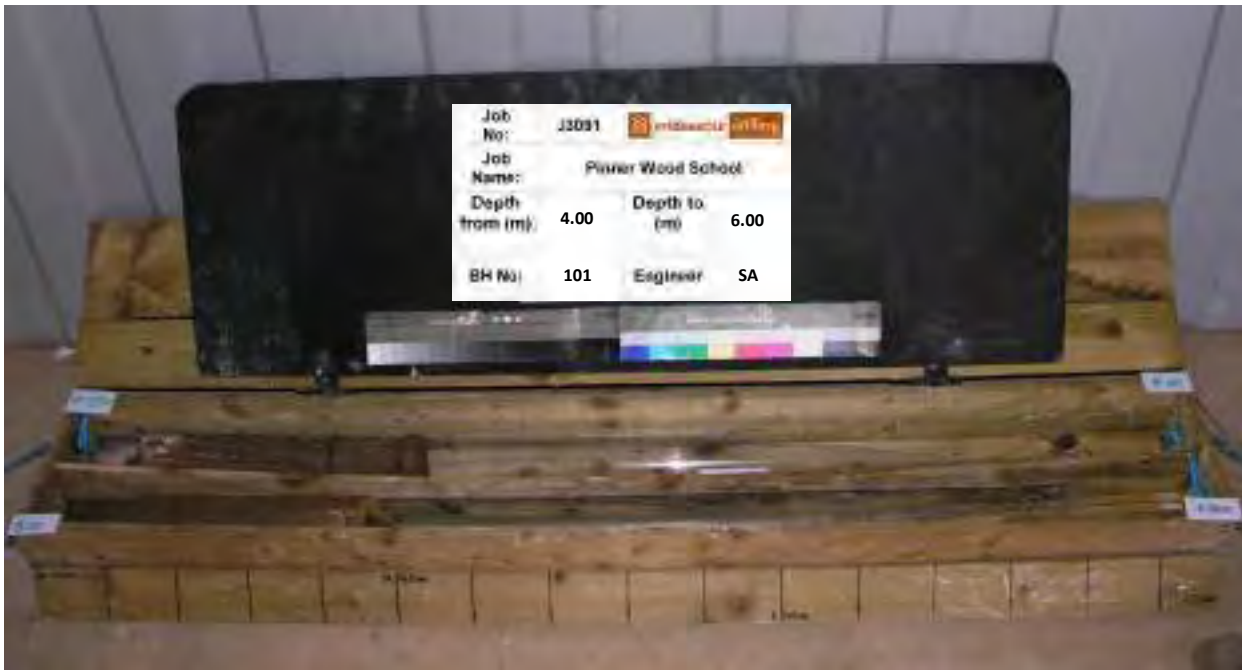
BH101: 4.00 - 6.00mbgl

16-08-2016	16:30	15.45							
17-08-2016	16:30	30.30							
1. Hand dug inspection pit excavated to 1.20mbgl prior to drilling. 2. Core recovery starting from 4.00mbgl due to subsidence and backfill of ground collapse. 3. No groundwater encountered.									
Water Strikes									
Chiselling			Installation				Strike (m) Casing (m) Sealed (m) Time (mins) Rose to (m) Remarks		
From (m)	To (m)	Duration	Remarks	Top (m)	Base (m)	Type	Dia (mm)		
HBSI CP Template Issue Number: 2 Issue Date: 09/06/2015

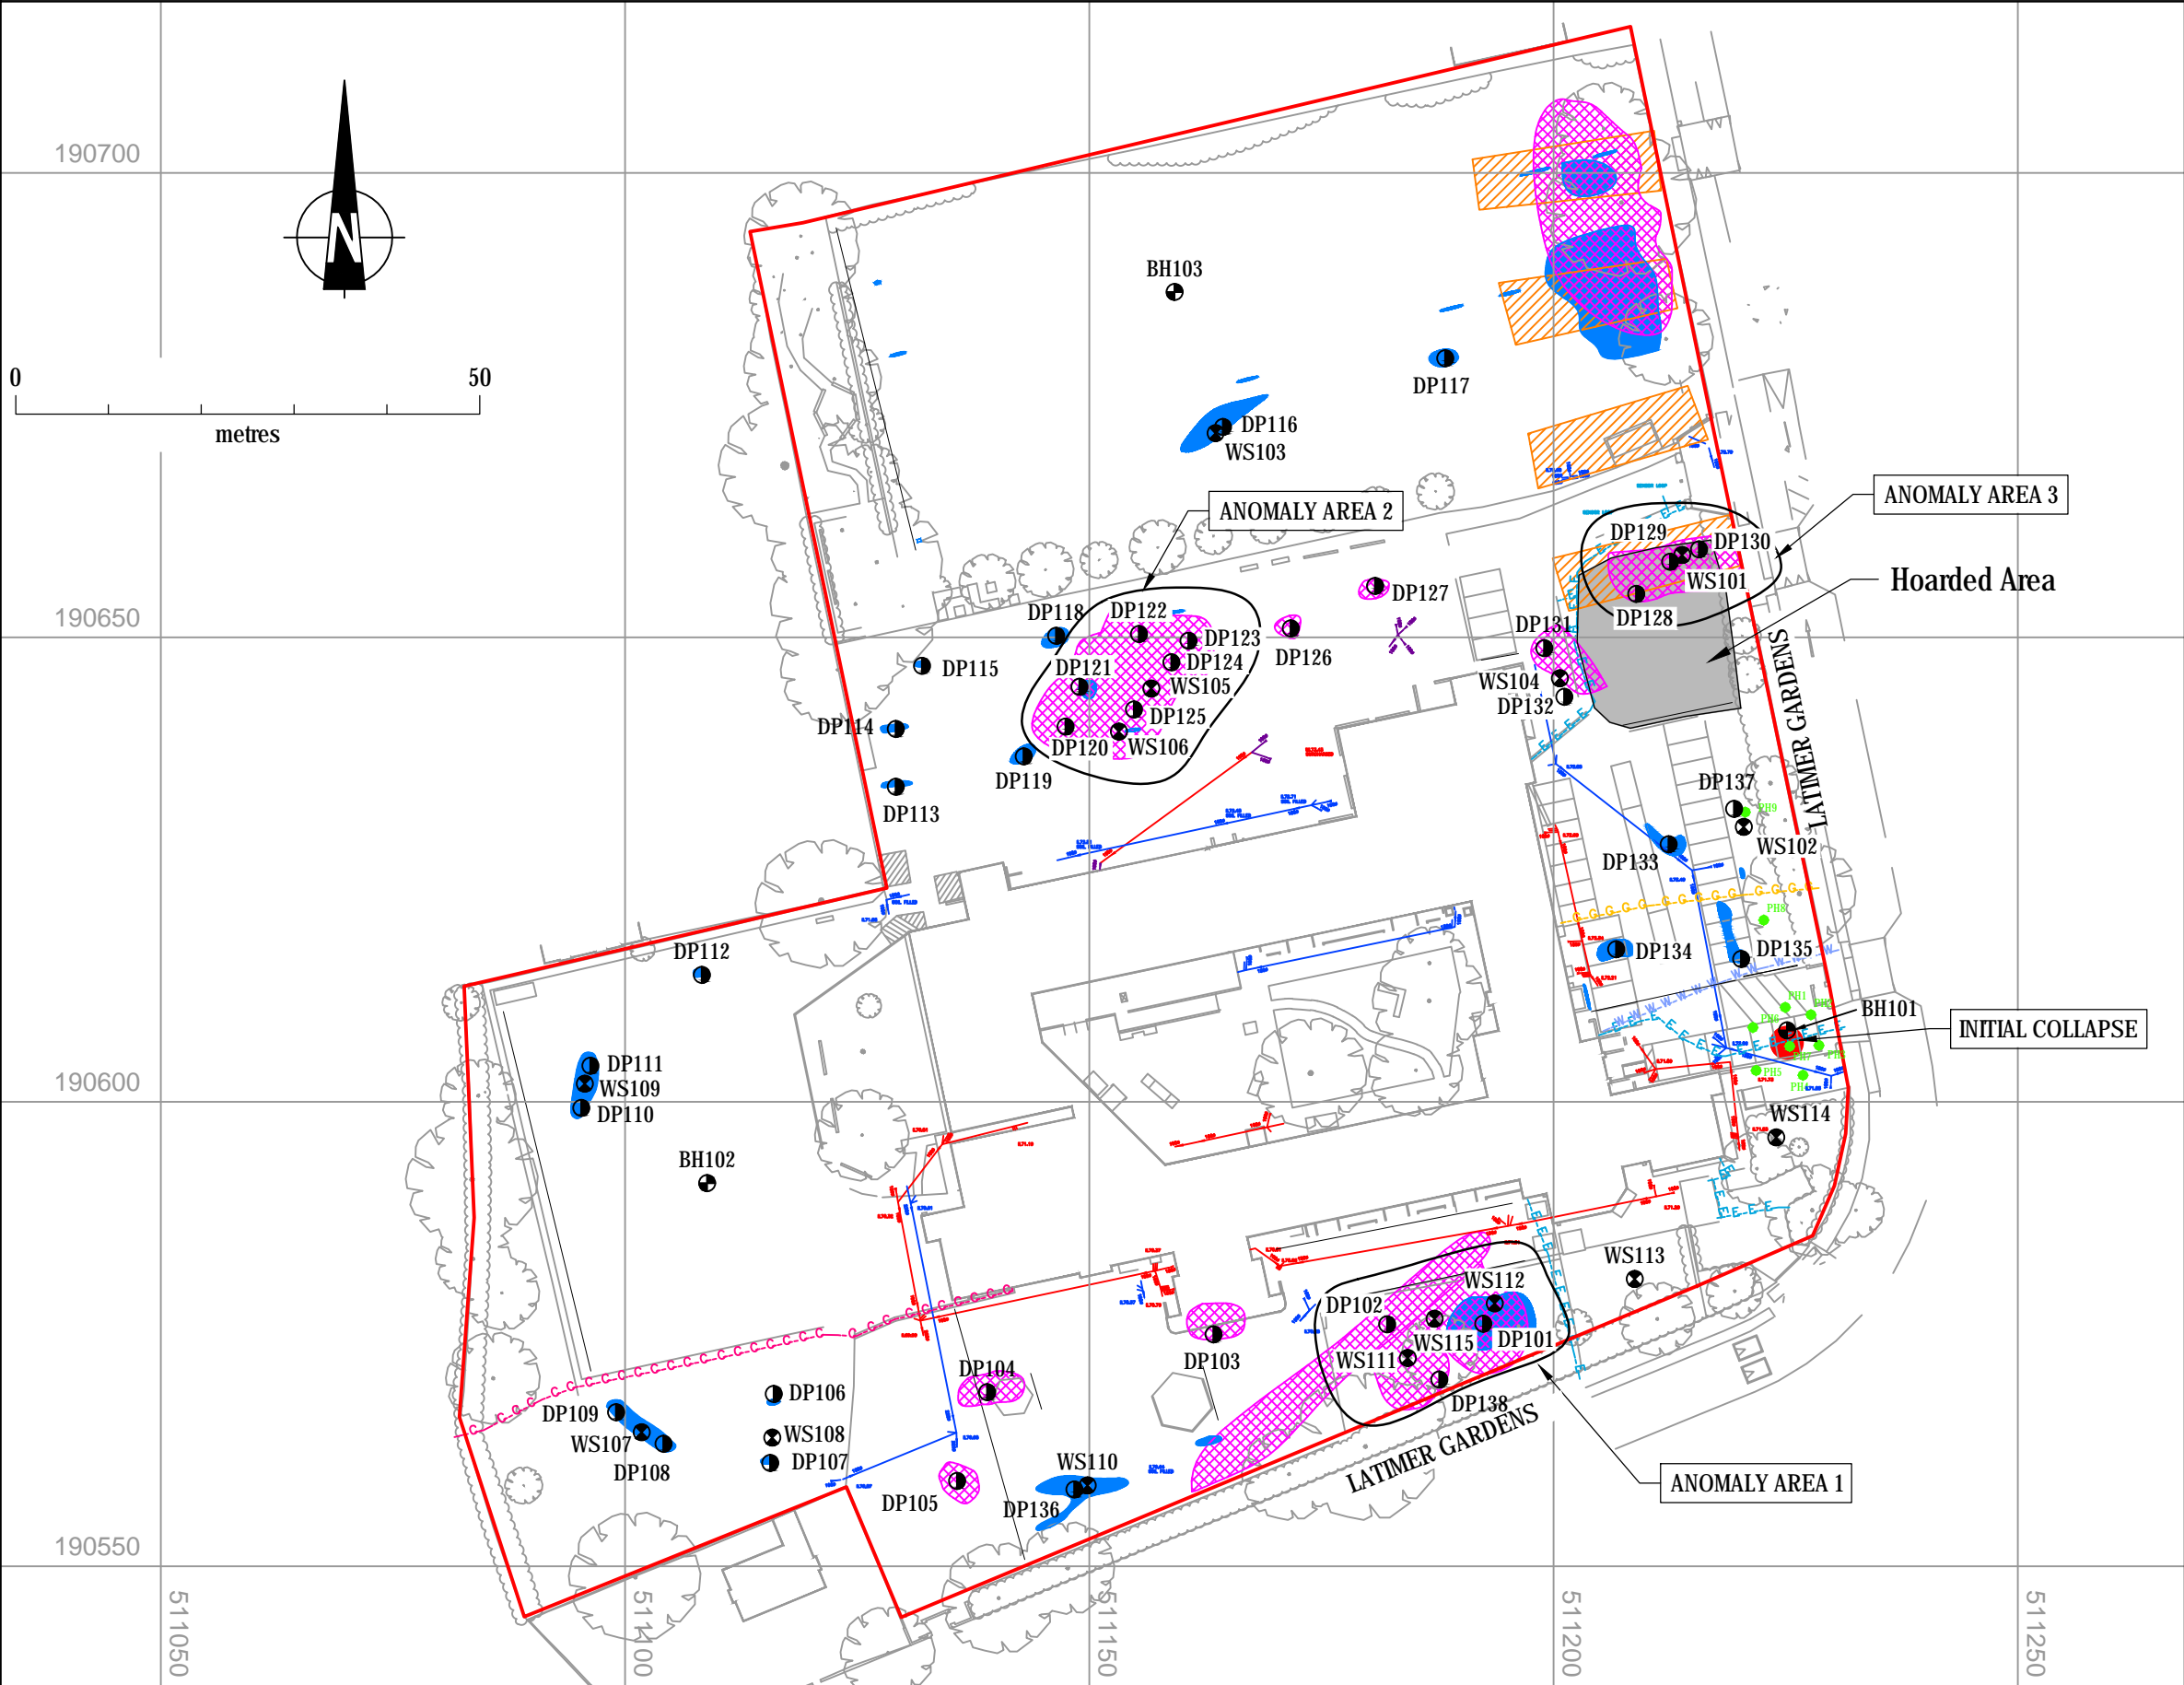
The collapse measured 3m in diameter and 2m in depth, the location of the feature is displayed in **Figure 2**. It is understood that the feature was backfilled, by Harrow Council, with loose free draining aggregate. The aggregate was end-tipped and as such is not compacted. Since the infill of the collapse the feature has settled it has been necessary to refill it over time. An electrical service cable was found traversing the feature and was still connected when the collapse occurred. It is not known if any damage was sustained to the cable during the collapse or backfilling.
