Update on works at the site of Pinner Wood School

This is the fourth of our regular updates on the work that our project team are undertaking at the site of Pinner Wood School. The site is currently closed after the discovery of previously unmapped chalk mine tunnels under the school building, some of which had collapsed roofs.

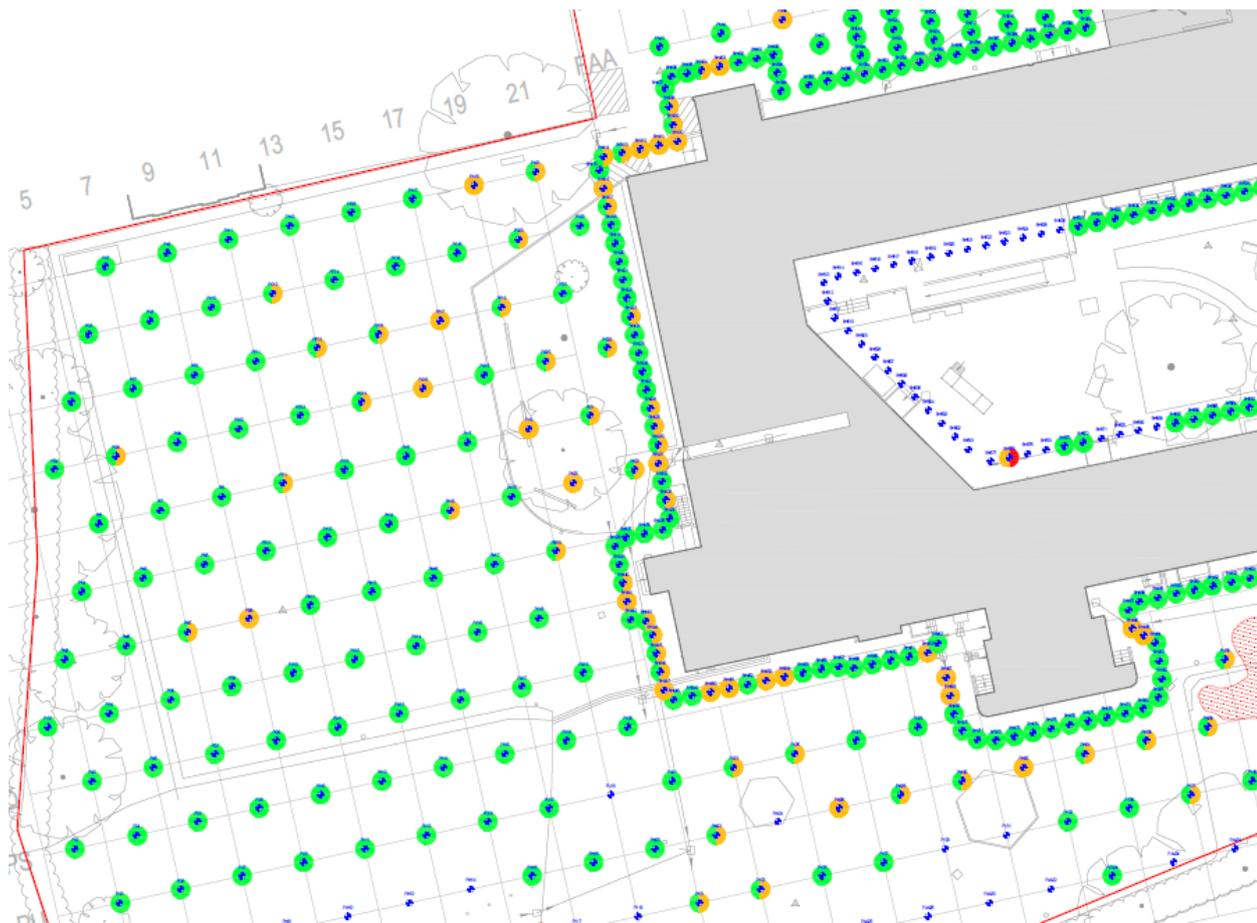
Findings west of the school as of 24 May:

We are pleased to report that our drilling continues to progress at a fast pace. We have now almost completed our grid pattern of boreholes across the site and the good news is that we have discovered no evidence of voids or broken ground to the west of the school.

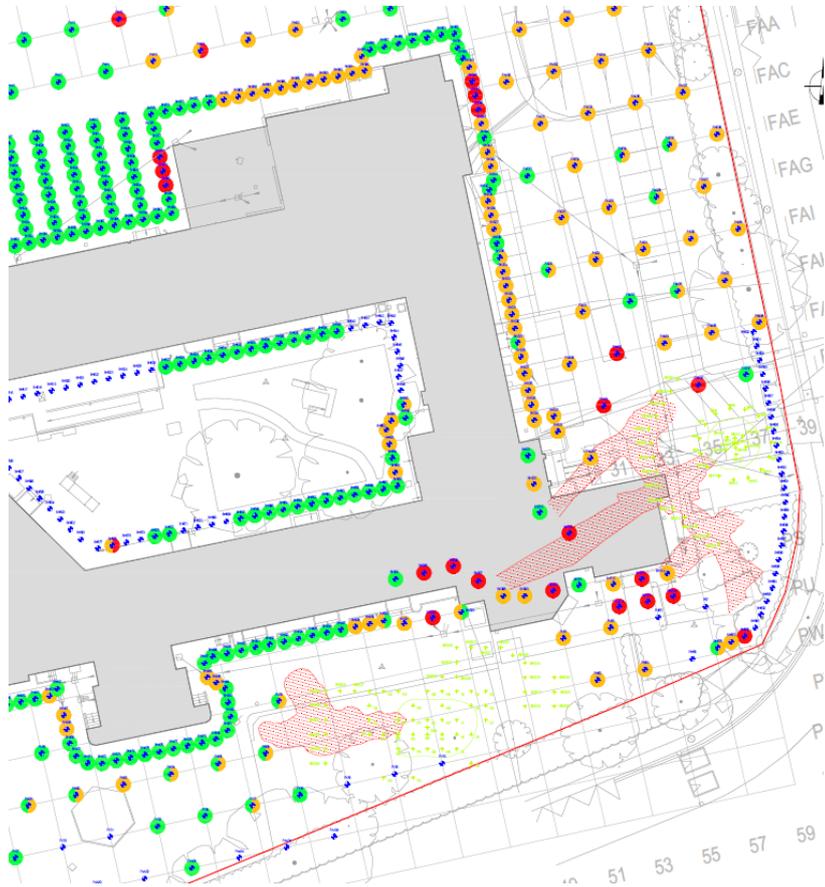
Findings east of the school, near the entrance, as of 24 May:

The next stage in the process is to deploy the laser scanner, provided by a company called Geoterra. It is scheduled to arrive and begin work tomorrow, Thursday 25th May and continue operating until Friday 2nd June. We are preparing 26 boreholes for laser scanning (largely corresponding to the red circles on the maps overleaf), with the intention of creating a thorough 3-D picture of the condition of the ground at depth. In addition, we will be sending high definition cameras and lights down those same boreholes, to help us gain more information.
